3 WEST OF US 83 NORTH

IDENTIFICATION	
(1) State Names	North Dakota
(8) Structure Number	0094-156.609
(5) Inventory Route	00094
(2) Highway Agency District	61
(3) County Code	Morton, North Dakota

(4) Place Code	7200
(6) Features Intersected	MISSOURI RIVER
(7) Facility Carried	INTERSTATE 94
(9) Location	3 WEST OF US 83 NORTH
(11) Mile Point	156.576 mi

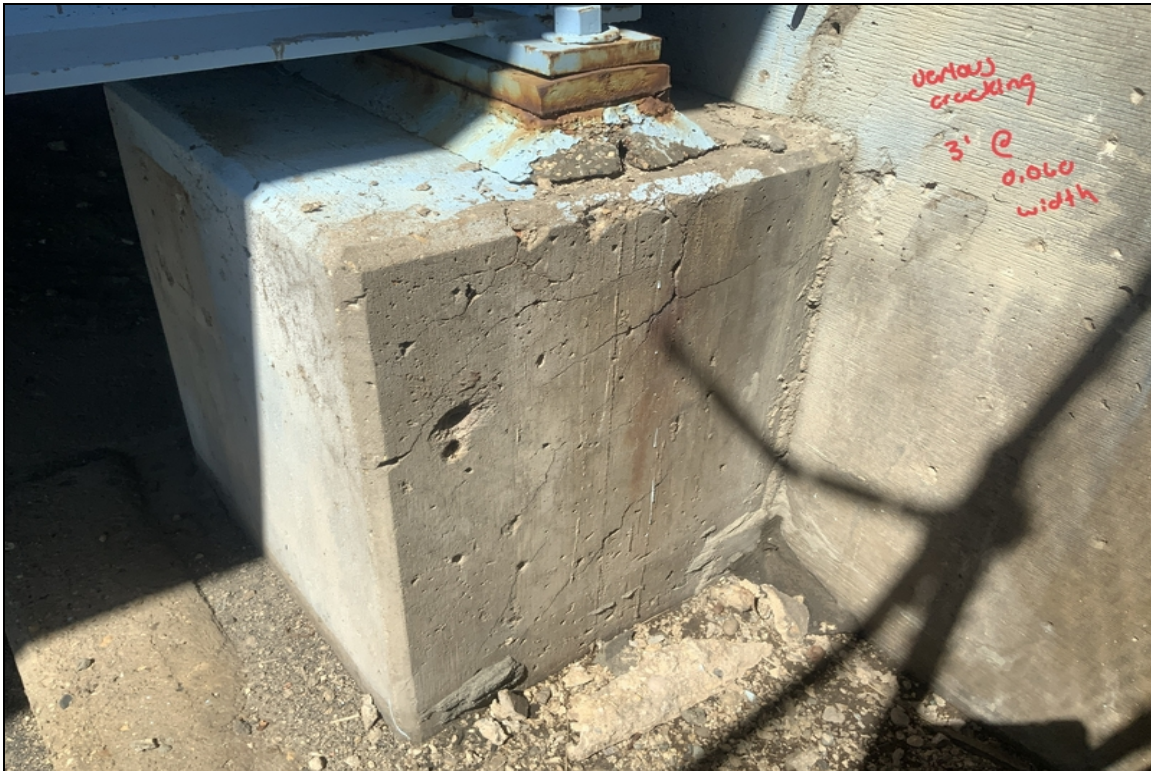
Facing NE and Downward. Various Cracking to EB I-94 Bearing 2 at East Abutment.

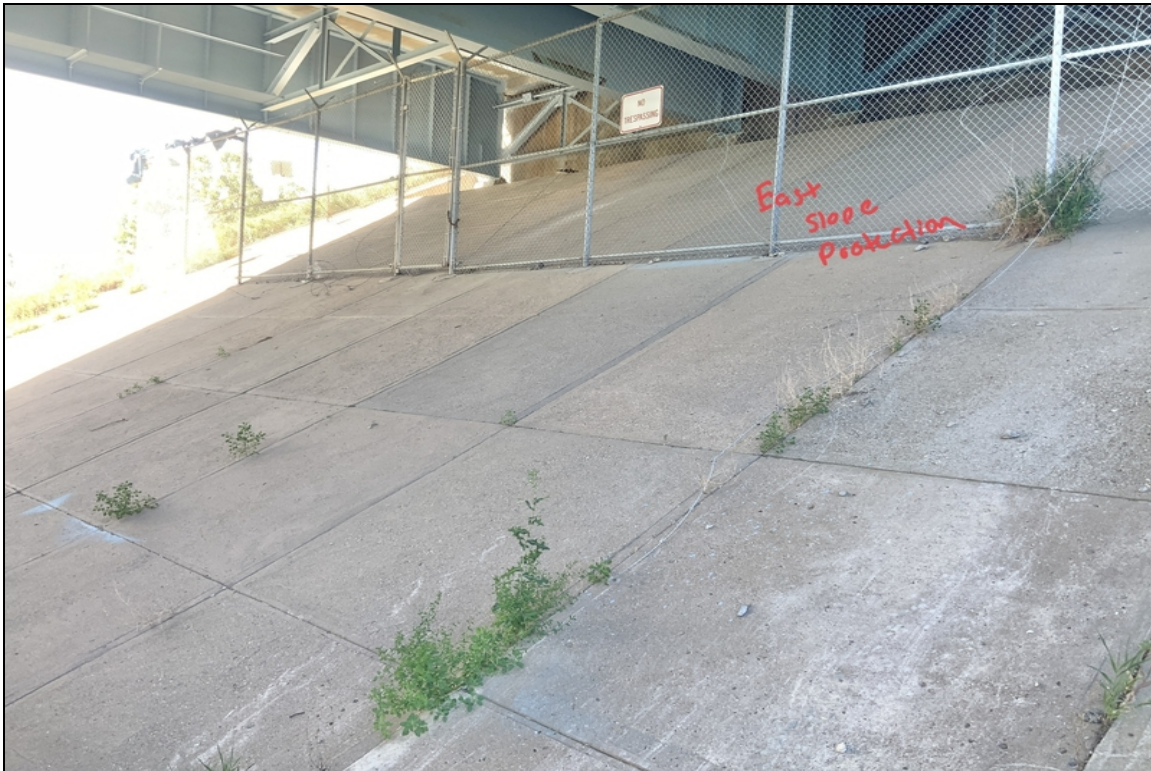
Facing SW. General View of East Slope Protection.

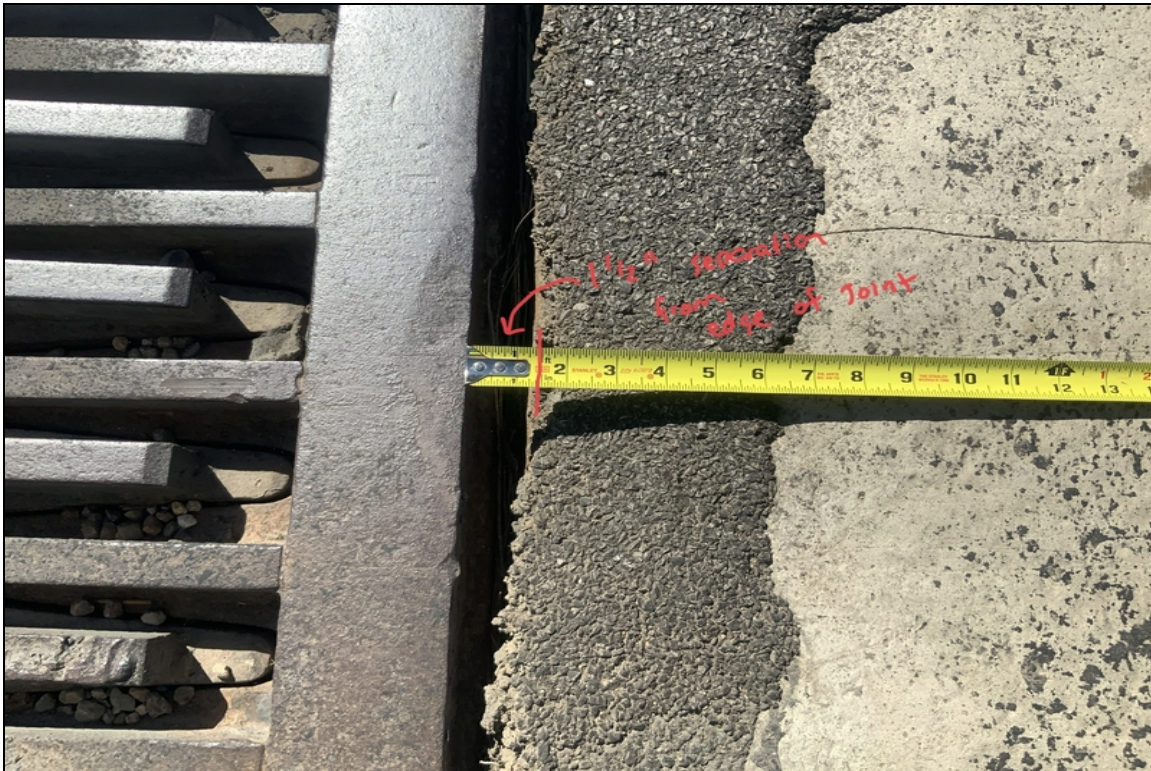
Facing South and Downward. Separation of Patch Material from Joint along West side in the WB DL.

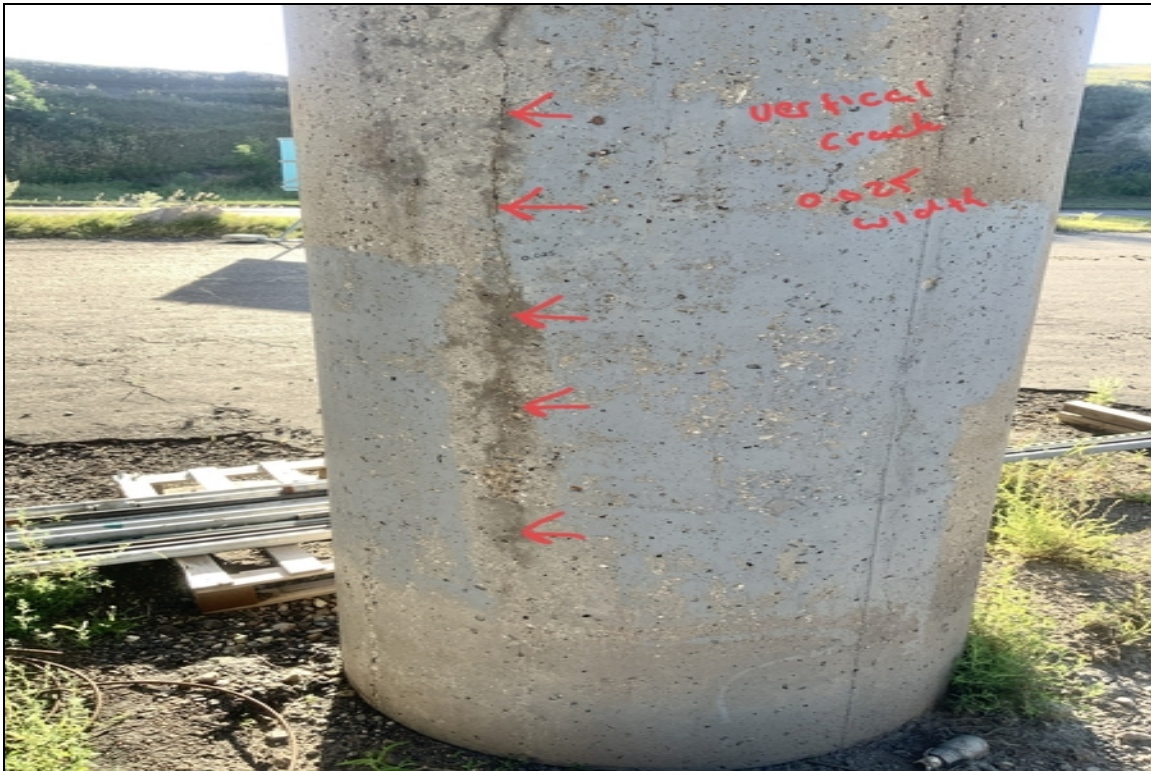
Facing South. Vertical Cracking to Pier 7 Column 7.

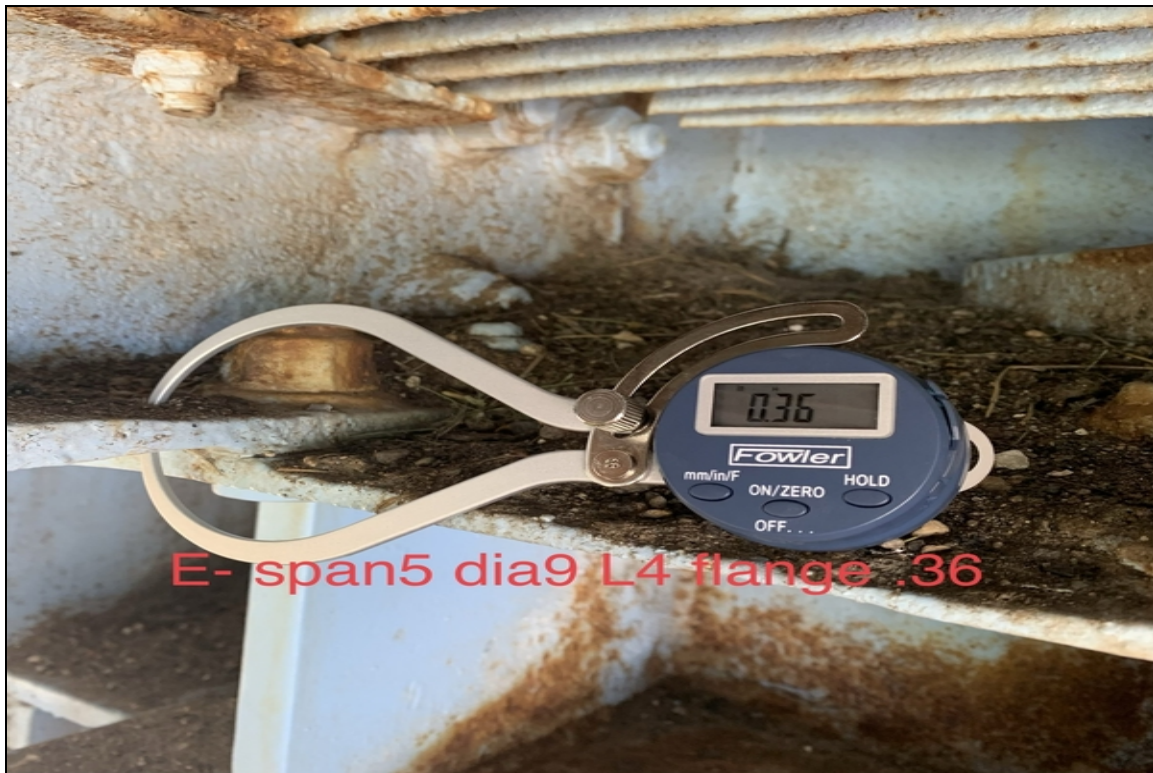
WB span 5 diaphragm 9 L4 flange .36" thinning thickness (E)

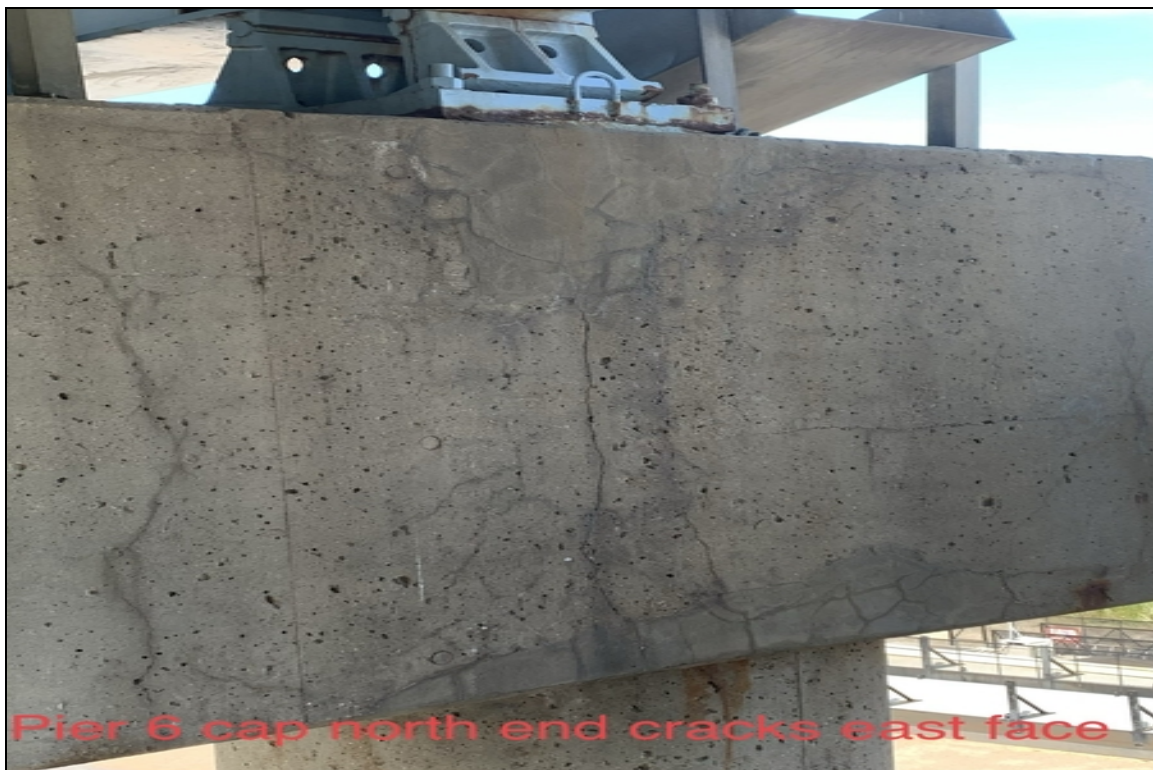
WB pier 6 cap north end East face cracks

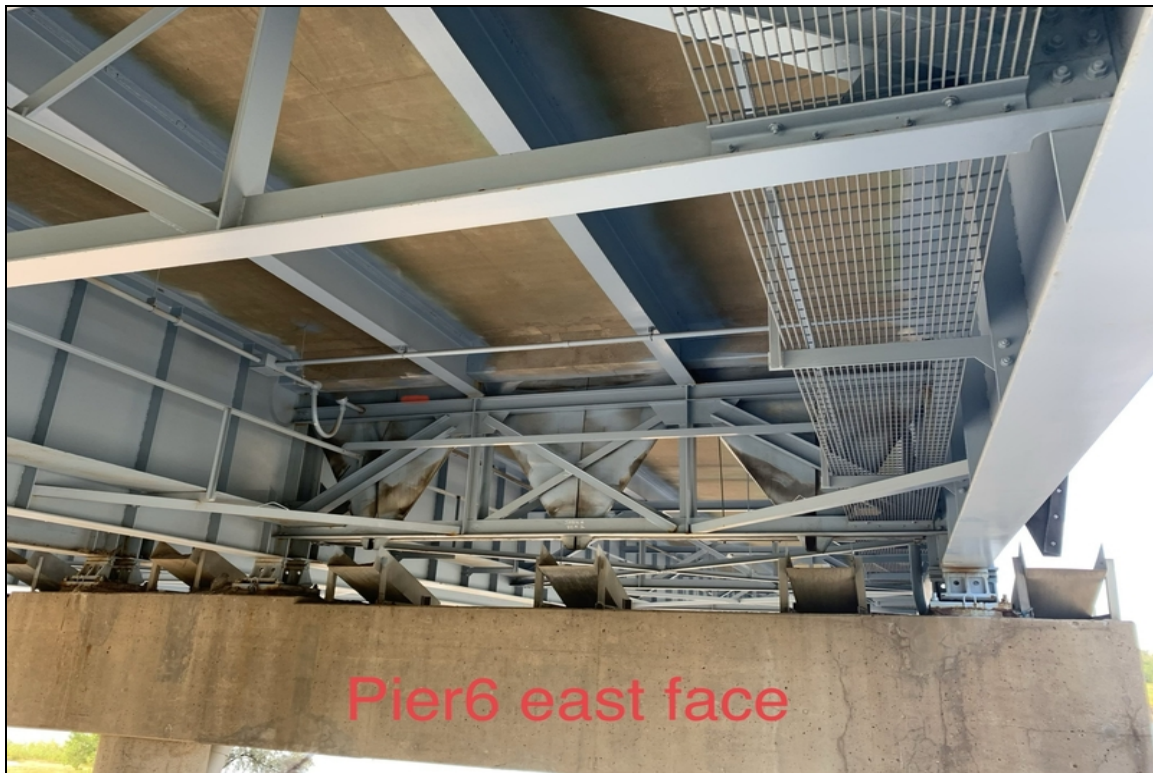
Wb pier 6 east face

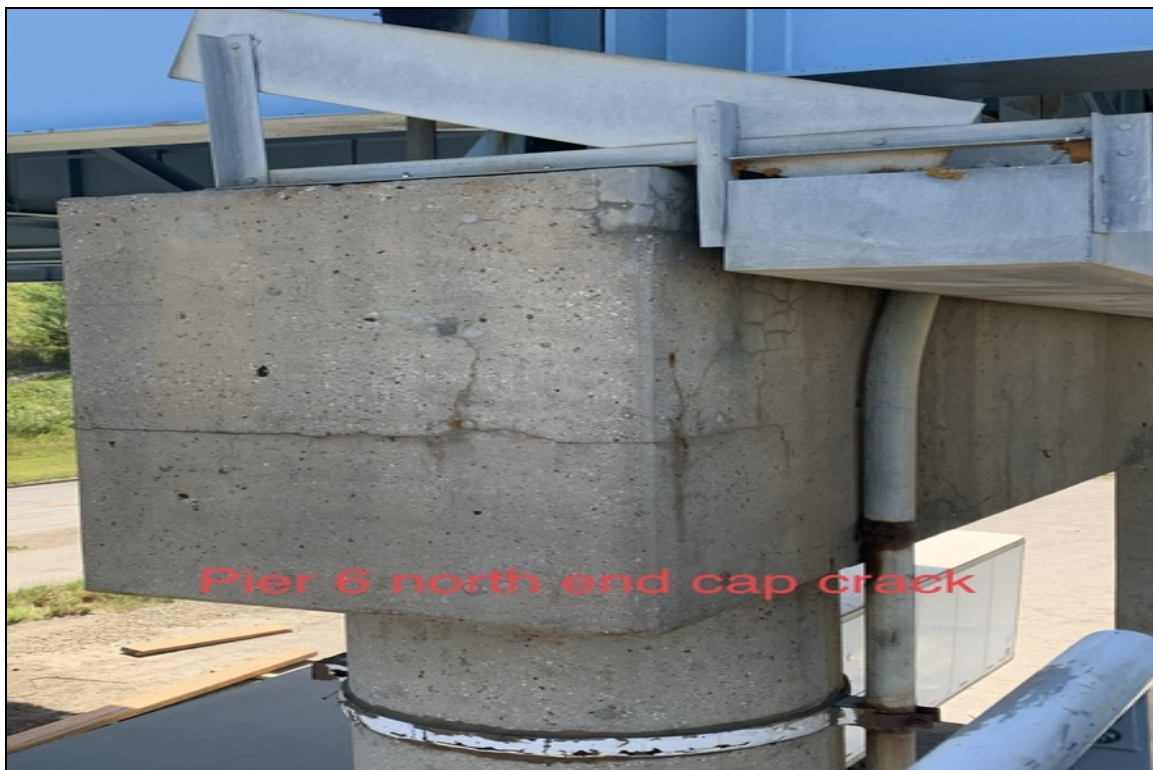
WB pier 6 north end cap cracks

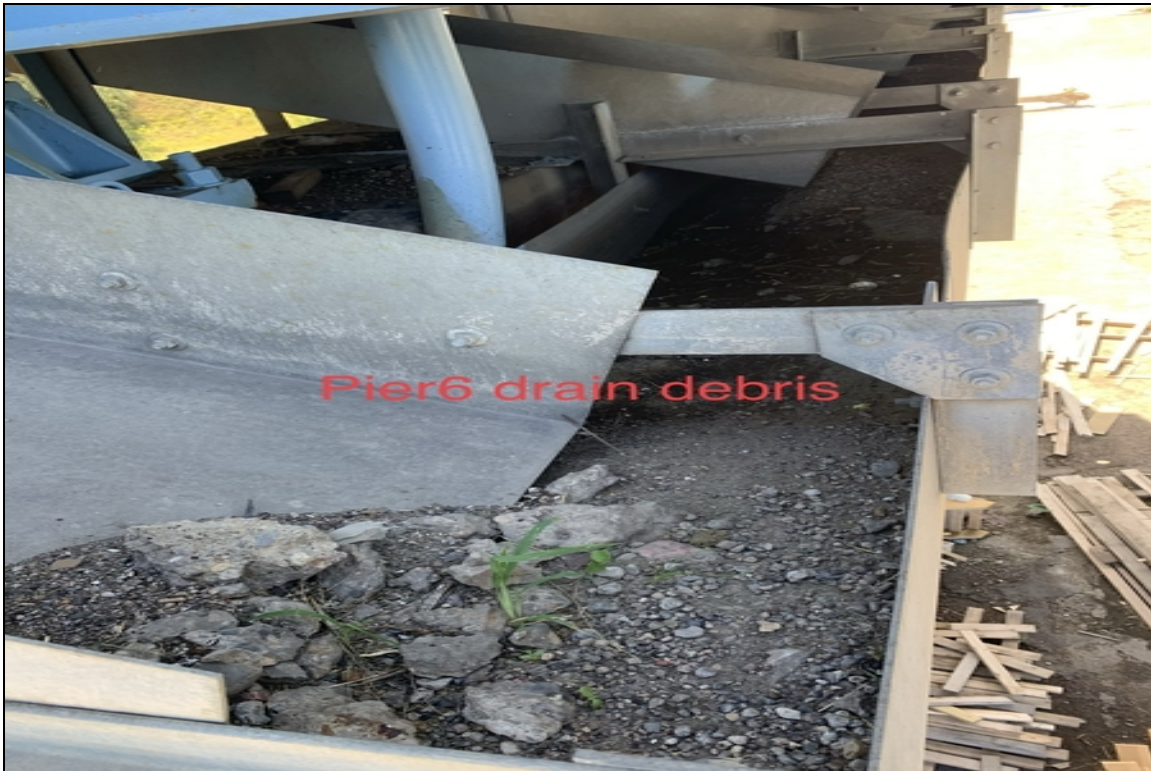
WB pier 6 drain system debris

Recommendation to flush Gutter Lines. Pier 2 and Pier 6 with debris filling up in both Expansion Joints. Recommendation to Flush out the Joints. Recommendation to clean out drainage systems. Sediment and Aggregate Buildup along WB and EB DL Gutter Lines.

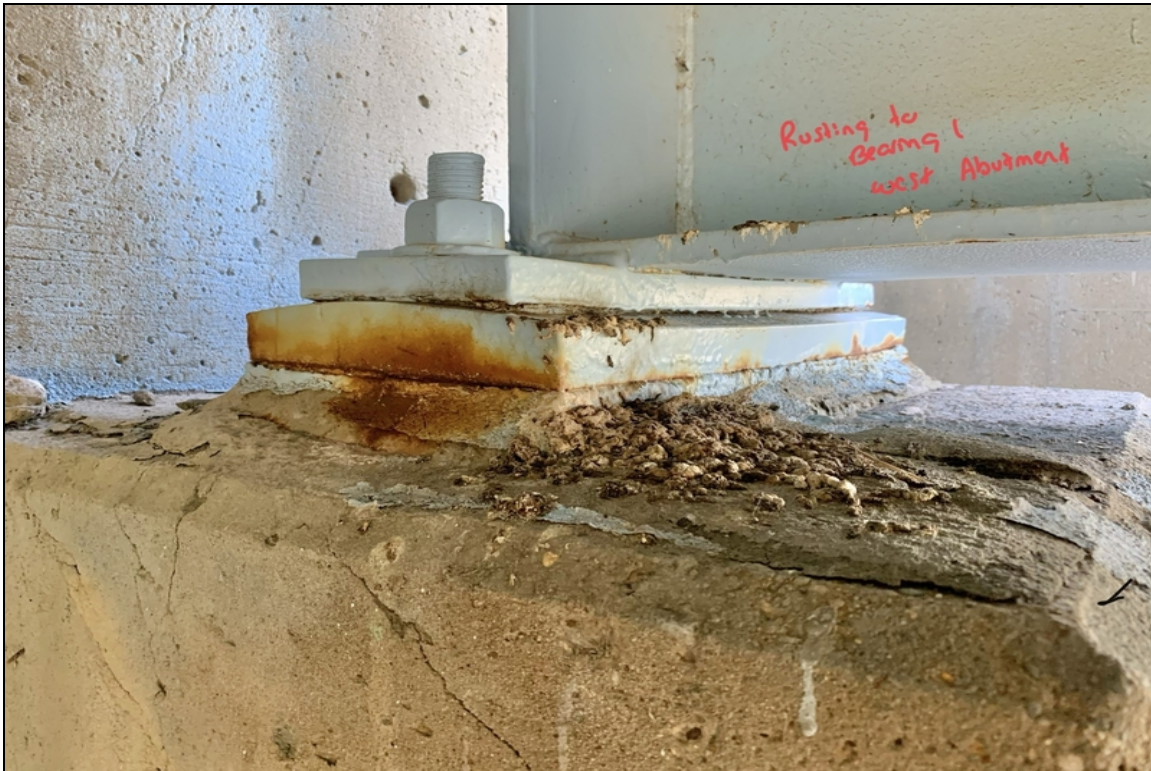
Facing NW. Rusting along Baseplate of Bearing 1 at West Abutment.

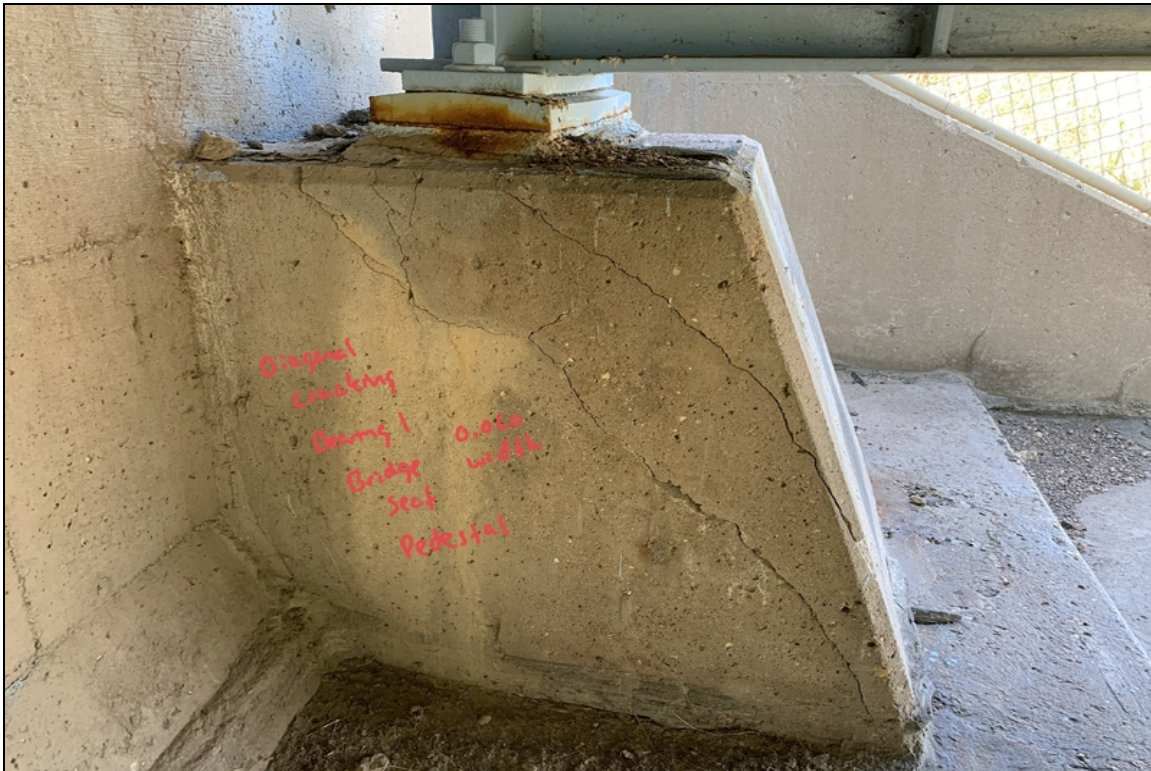
Facing North. Various cracking to WB I-94 Bearing 1 Bridge Seat Pedestal at West Abutment.

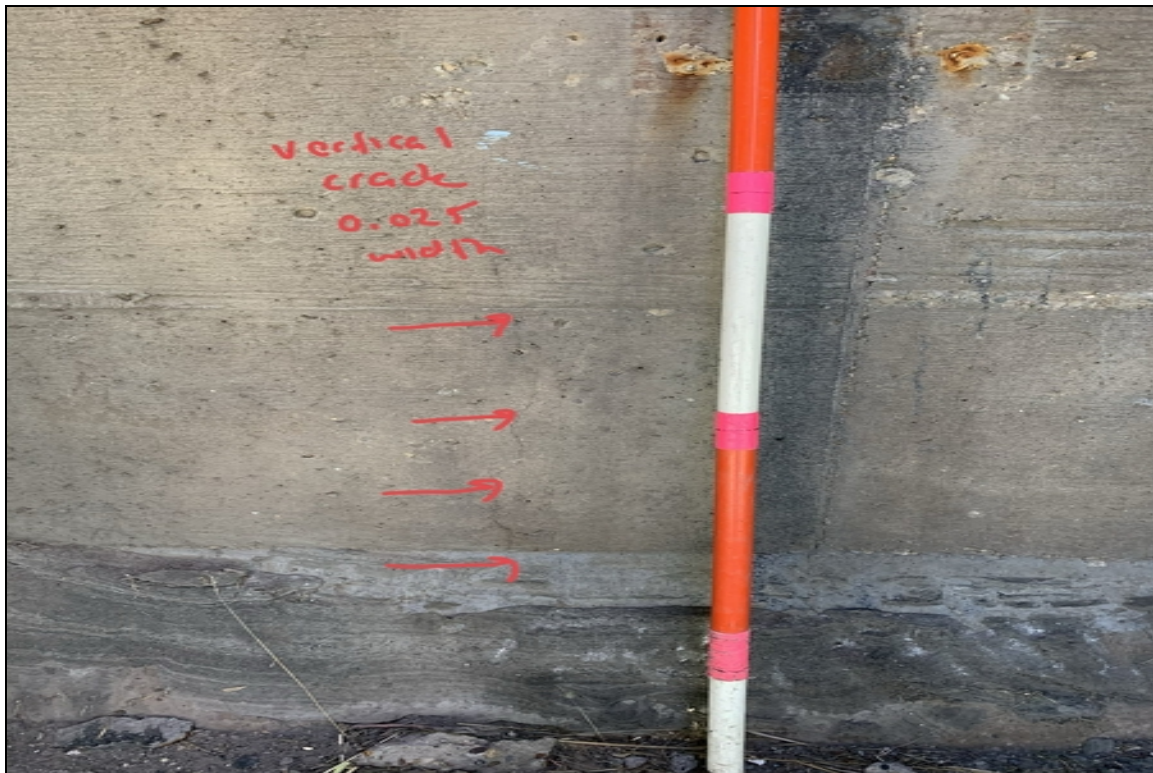
Facing West. Vertical Cracking to West Abutment Backwall in-between WB I-94 Girder2 1 and EB I-94 Girder 1.

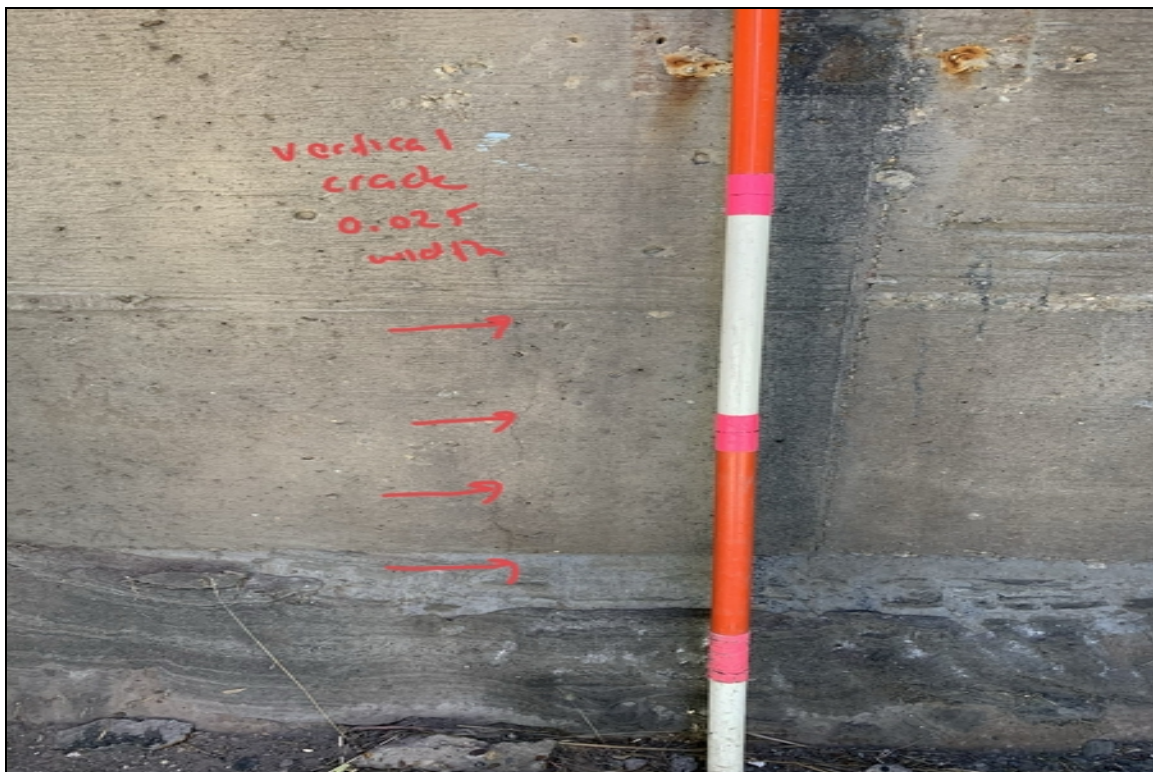
Facing West. Vertical Cracking to West Abutment Backwall in-between WB I-94 Girder2 1 and EB I-94 Girder 1.

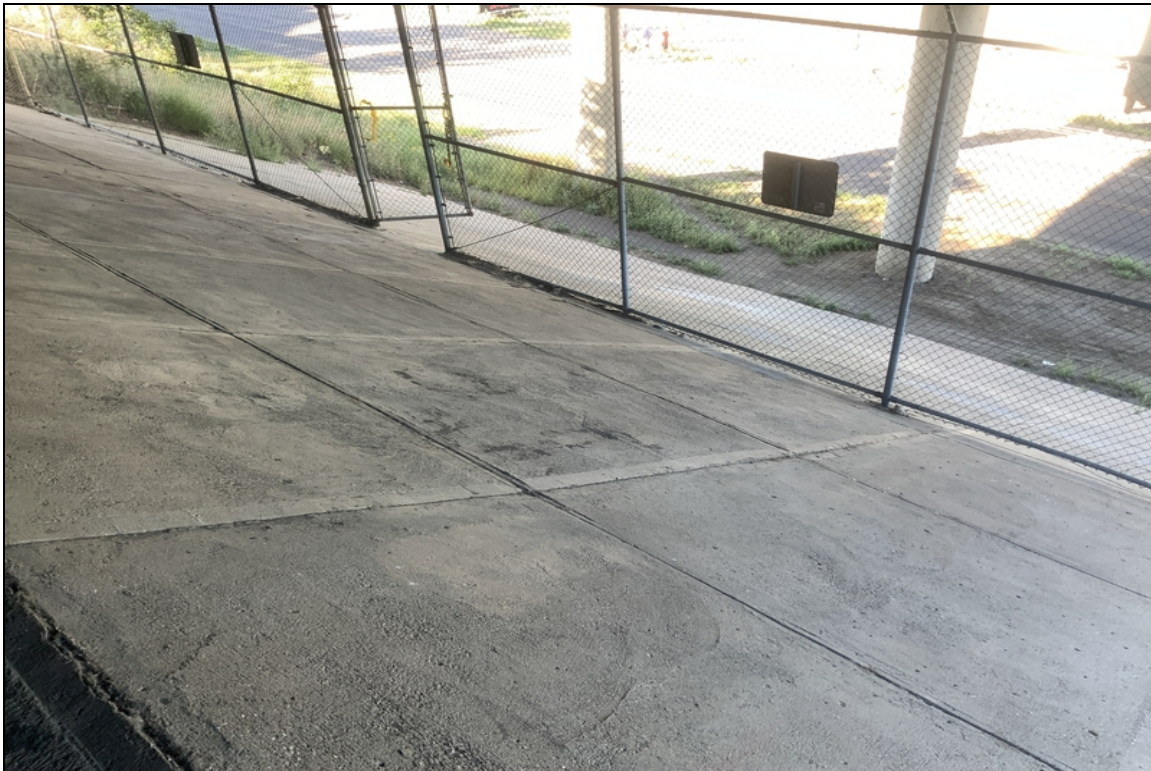
Facing SW. General View of East Slope Protection.

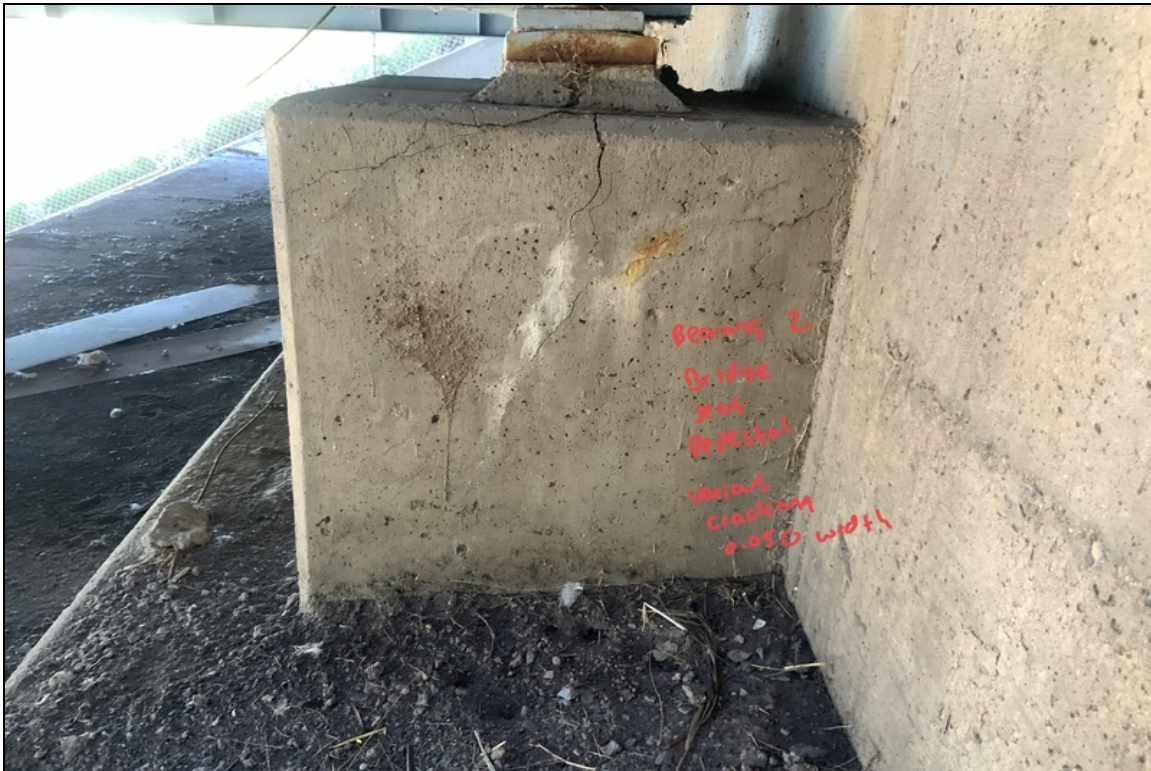
Facing North. Various cracking to WB I-94 Bearing 2 Bridge Seat Pedestal.

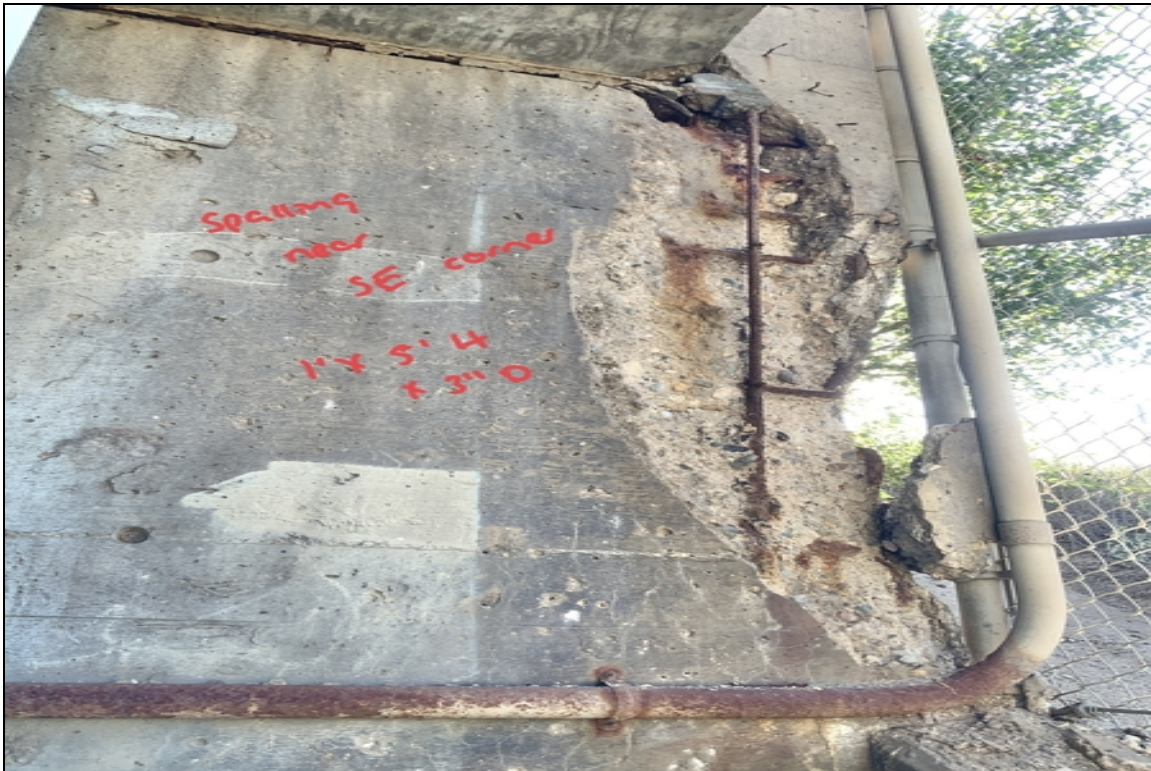
Facing SE. Spalling to East Abutment near SE Corner where it meets the Wing.

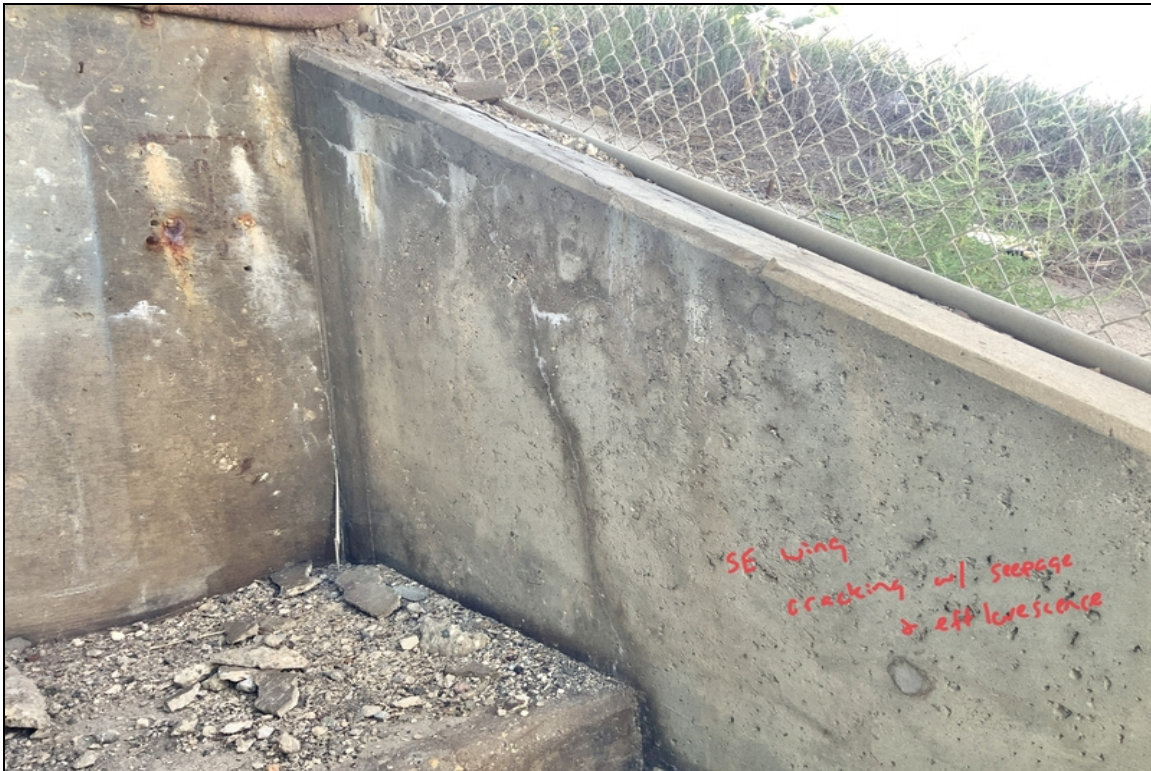
Facing SE. Some Diagonal and Vertical cracking with some seepage and efflorescence along SE Wing.

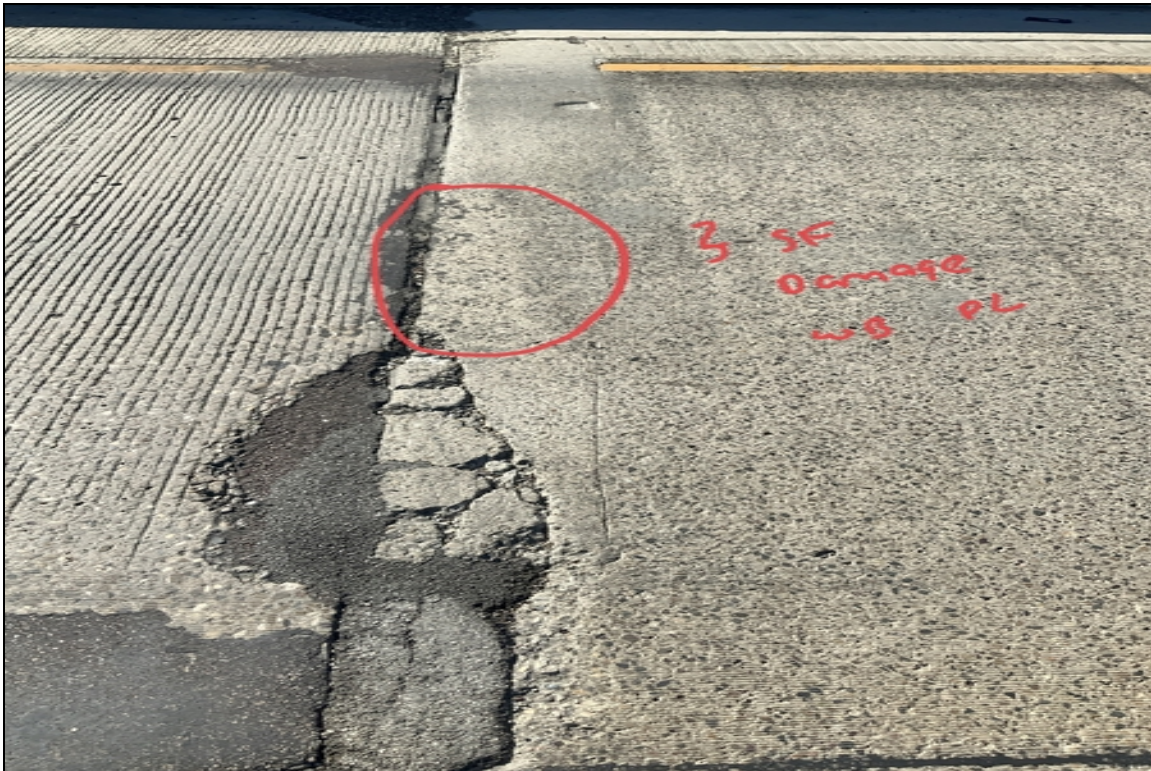
Facing South and Downward. Blade Damage across East End of Bridge Deck in the WB PL.
